RUST CONTAMINATION

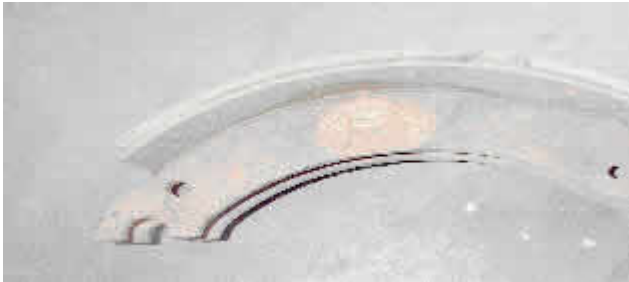
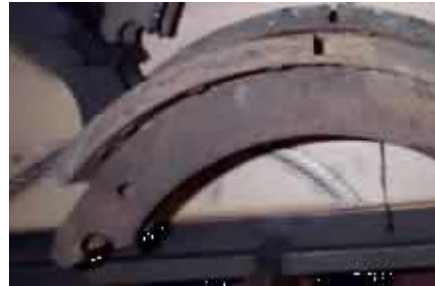
Steel brake shoes are the area of major concern to friction material. These chemicals, thru the heating and cooling of the brake systems, migrate to the steel shoe table and then establish corrosion between the friction material and the steel shoe table. This can be seen in the pictures above. Careful inspection and meticulous cleaning of the steel shoes along with the painting of these items only help the shoes withstand some of the corrosion. When magnesium or calcium chloride is used on the roads, corrosion is guaranteed to appear and cause damage.

Rust that invades the steel table will cause rust to get under the friction material, swell and create cracks and breakage of good friction material and ruin it before its full performance and life are experienced.

Rust contamination, **can cause** friction material cracking and overheating, and **must be taken** into consideration when doing any diagnosis of brake problems. The term "rust jacking" is the name given to contamination of the steel components such as brake shoe tables and attaching hardware and components.
